**ENGINEERING GEOLOGIC &
GEOTECHNICAL INVESTIGATION
4-LOT RESIDENTIAL DEVELOPMENT
ZMAY PROPERTY
1551 CRYSTAL SPRINGS ROAD
SAN MATEO COUNTY, CALIFORNIA**

February 10, 2014
Project No. 1847-1R1

**RE: ENGINEERING GEOLOGIC &
GEOTECHNICAL INVESTIGATION,
4-LOT RESIDENTIAL DEVELOPMENT,
ZMAY PROPERTY,
1551 CRYSTAL SPRINGS ROAD,
SAN MATEO COUNTY, CALIFORNIA**

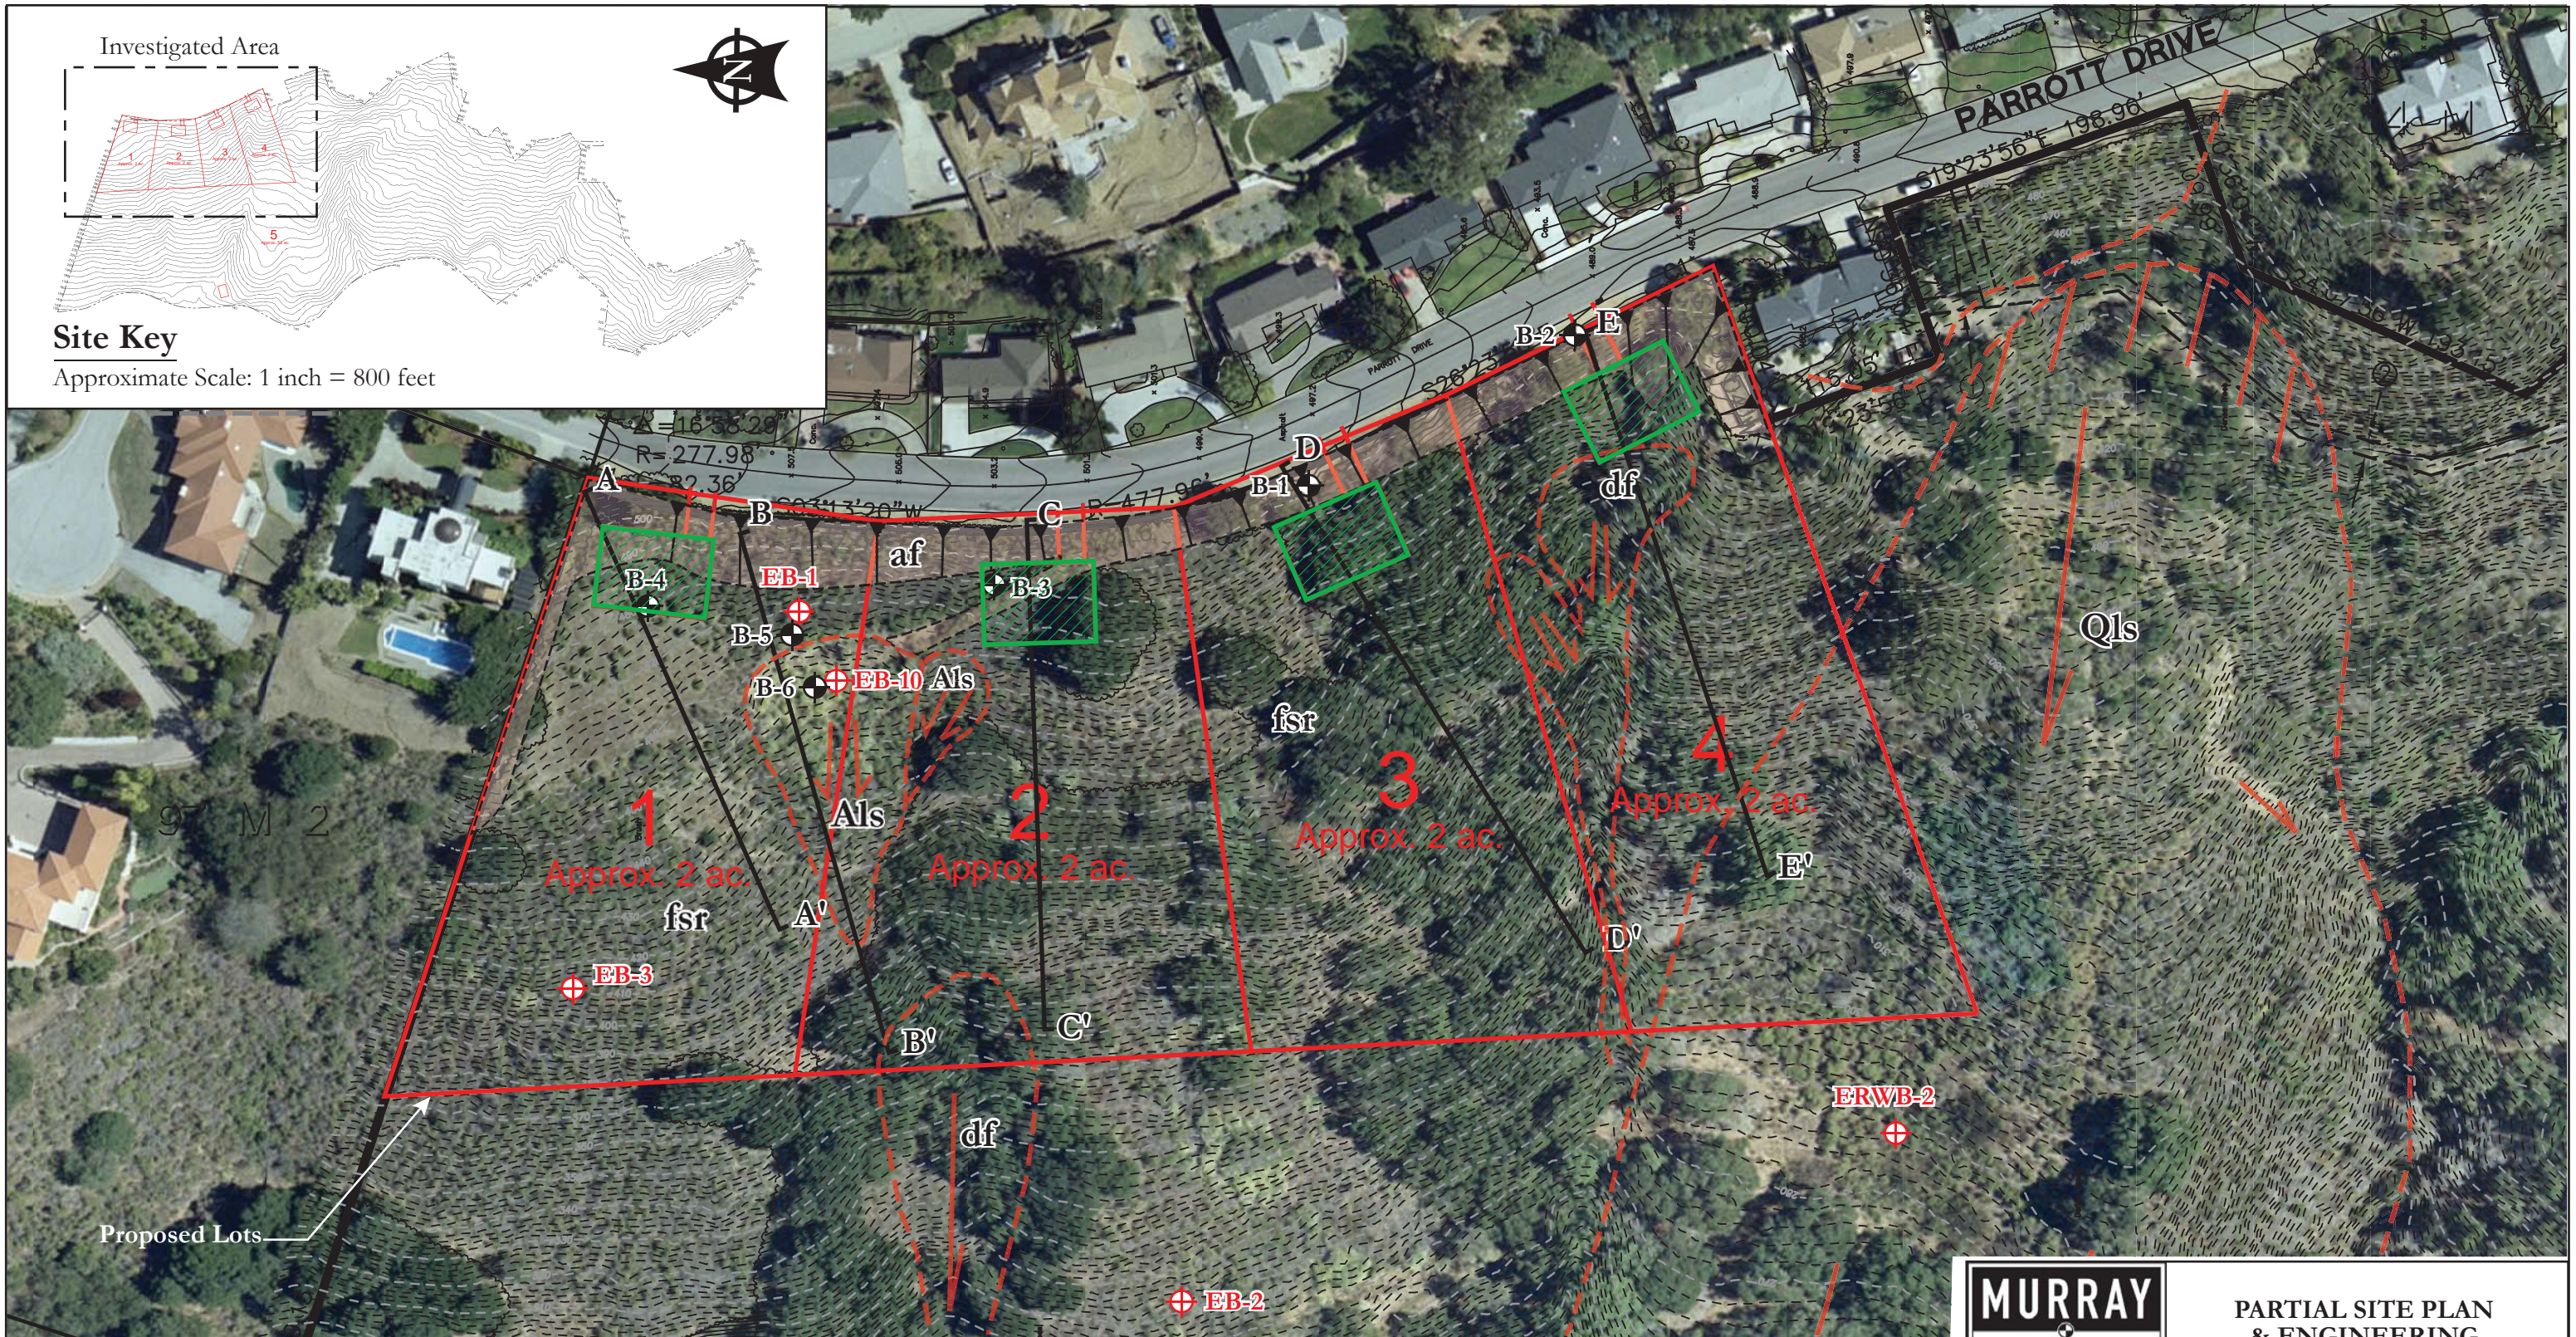
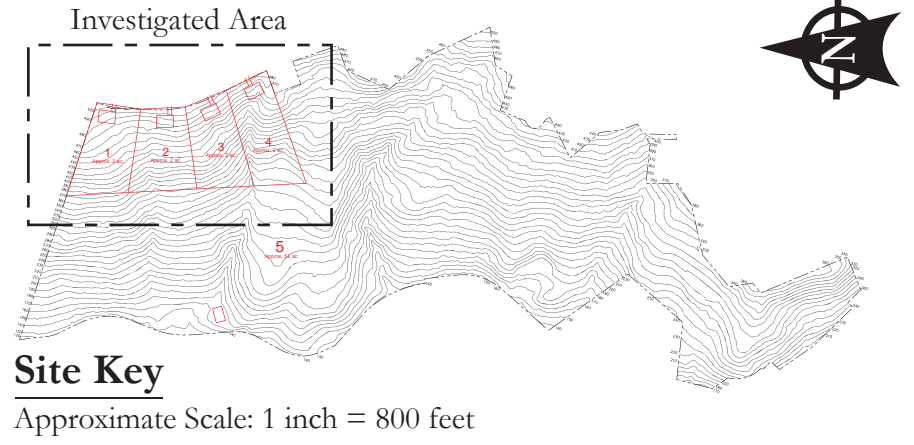
PARTIAL SITE PLAN & ENGINEERING GEOLOGIC MAP	
ZMAY RESIDENTIAL SUBDIVISION 1551 CRYSTAL SPRINGS ROAD SAN MATEO COUNTY, CALIFORNIA			
PROJECT NO. 1847-1R1	FEBRUARY 2014	FIGURE A-2

An active relatively shallow landslide is located along the property boundary between Lots 1 and 2. This feature was initially mapped by SCI in 1983. Based on our review of aerial photographs and our site reconnaissance, it appears that this feature is larger than initially mapped by SCI. It appears that a 40-foot wide failure appears to have occurred along the downhill side of the graded access road on Lot 2, widening the area of the active landslide. This active landslide was absent from the 1943 and 1968 aerial photographs, but appeared in the latest photographs following construction of the graded access road. In our opinion, grading associated with construction of this road is likely the main probable cause of the landslide. Based on our subsurface exploration, it appears that this active landslide is less than 10 feet thick in depth.

In general, the exploratory borings encountered variable amounts of fill and colluvium underlain by sandstone and sheared rock from the surface to the full depth explored of 40 feet. The boring locations are presented on Figure A-2, Partial Site Plan & Engineering Geologic Map and detailed logs of each boring are presented in Appendix B. A general description of the subsurface conditions and the approximate location of each exploratory boring are described hereunder.

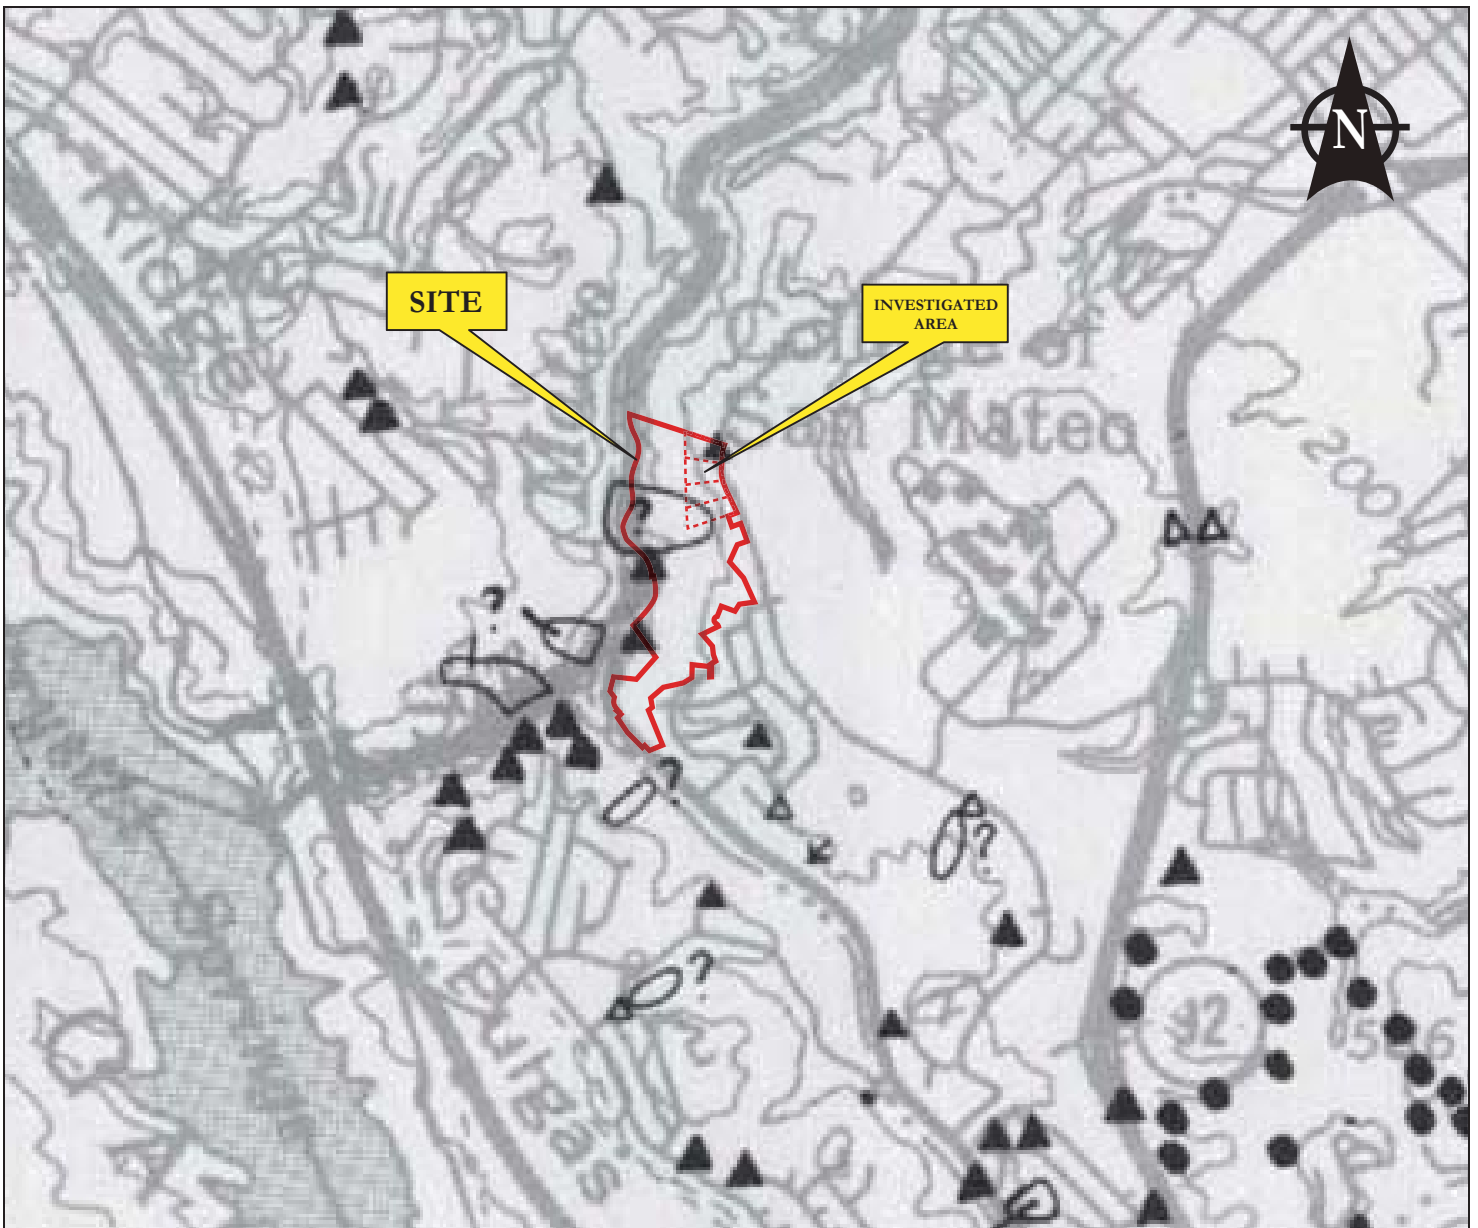
ZMAY RESIDENTIAL SUBDIVISION 1551 CRYSTAL SPRINGS ROAD SAN MATEO COUNTY, CALIFORNIA		SAN MATEO COUNTY LANDSLIDE DEPOSIT MAP
	PROJECT NO. 1847-1R1	FEBRUARY 2014	FIGURE A-4

According to the geologic map, the Geotechnical Hazard Synthesis Map for San Mateo County (Leighton and Associates, 1976), and the Preliminary Map of Landslide Deposits in San Mateo County (Brabb & Pampeyan, 1972), three relatively large landslides are mapped in the central portion of the property. According to the geologic map, the largest feature measures approximately 900 feet in length and 600 feet in width. The upper margin of this feature is located approximately 350 feet to the west (downhill) of Parrott Drive and extends down to Crystal Springs Road, crossing the southwest corner of Lot 4. The second mapped landslide is approximately 700 feet long and 500 feet wide and is located immediately south of the first landslide. In addition, smaller landslide features are mapped in the southern portion of the lot and at the northeast corner just off the property. The relevant portions of these maps are included as Figure A-4, San Mateo County Landslide Map and Figure A-5, San Mateo County Geotechnical Hazard Synthesis Map.

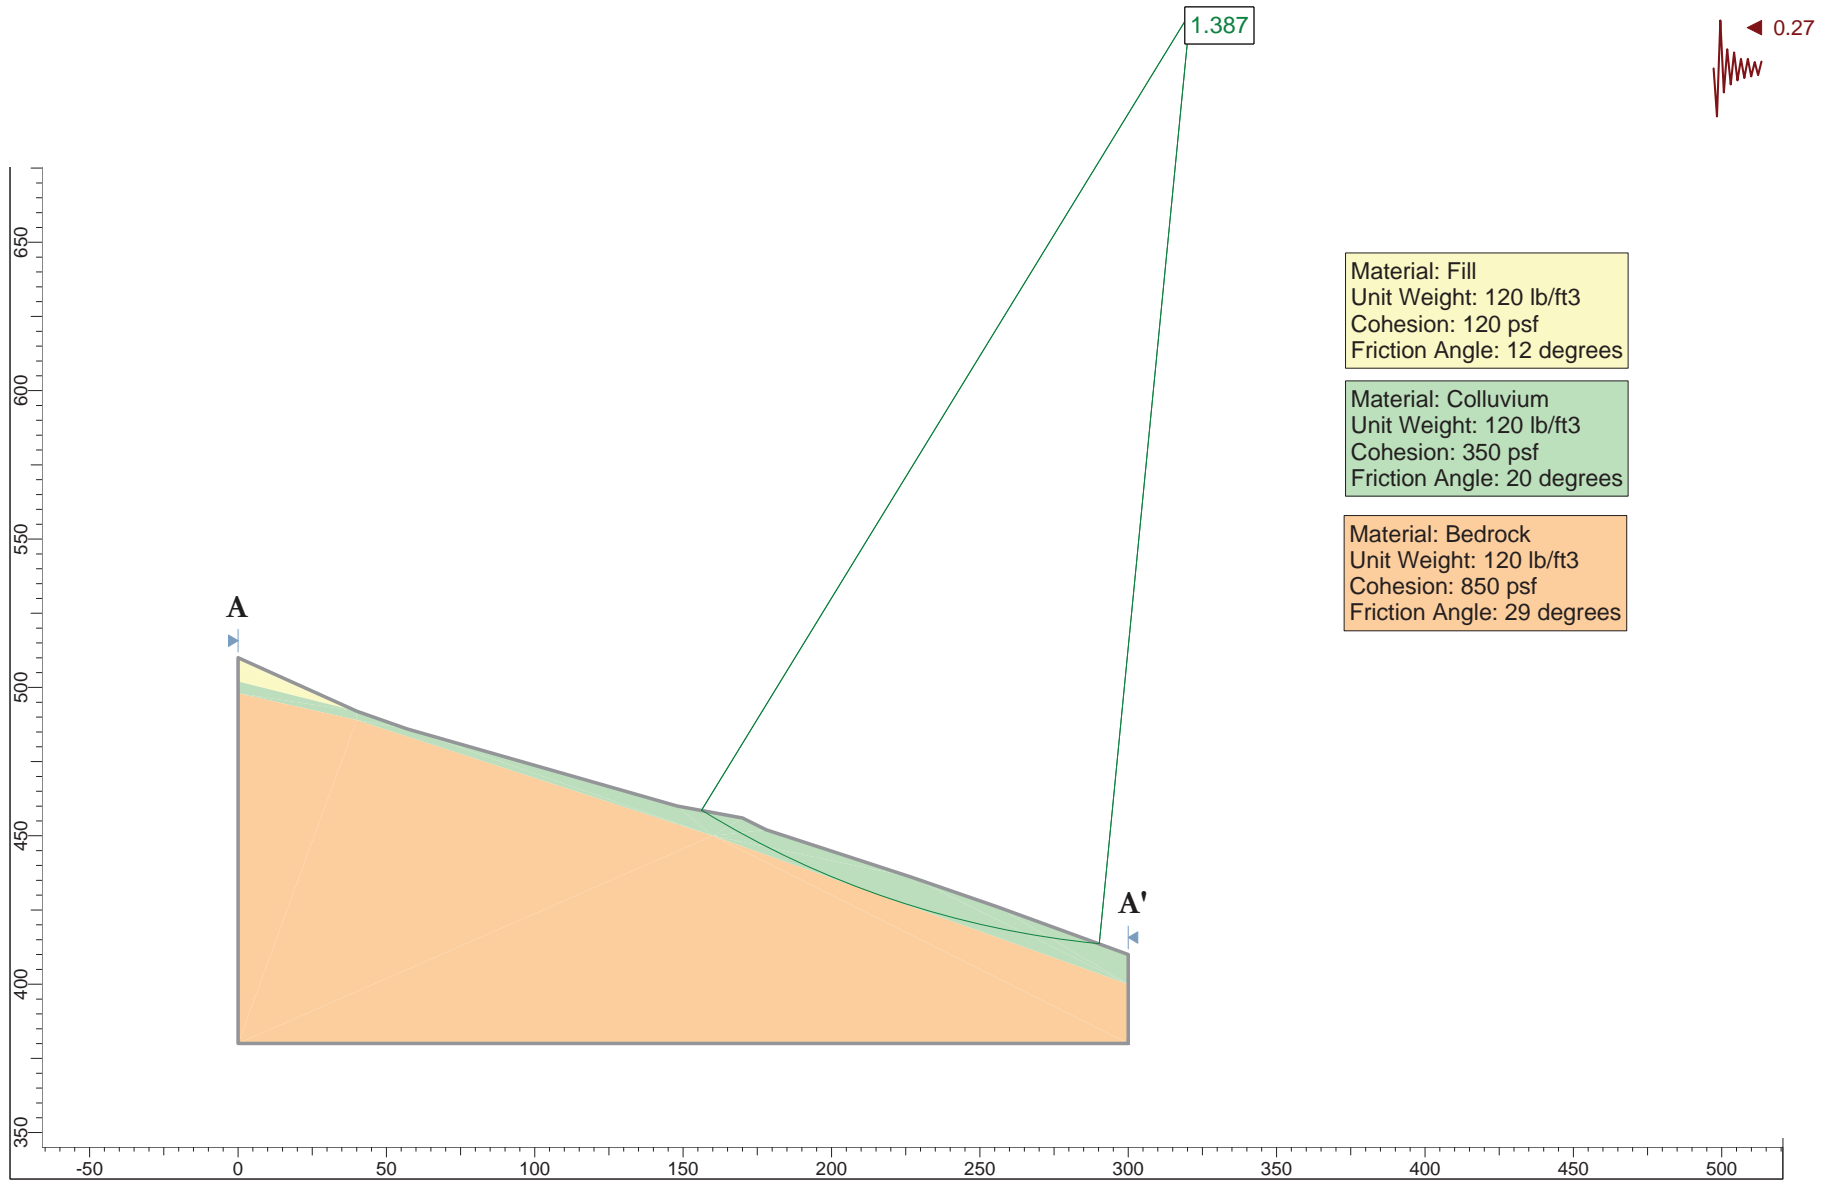
FIGURE A-11

The stability analyses yielded critical failure surfaces extending through the bedrock with a calculated factor of safety ranging from 1.00 to 1.39. The results of the slope stability
