APPENDIX A
Arborist Reports

RE: 30 CANYON LANE, REDWOOD CITY (UNINCORPORATED)

RE: CANYON LANE, REDWOOD CITY (UNINCORPORATED)

Attachment H - Applicant's Arborist Report

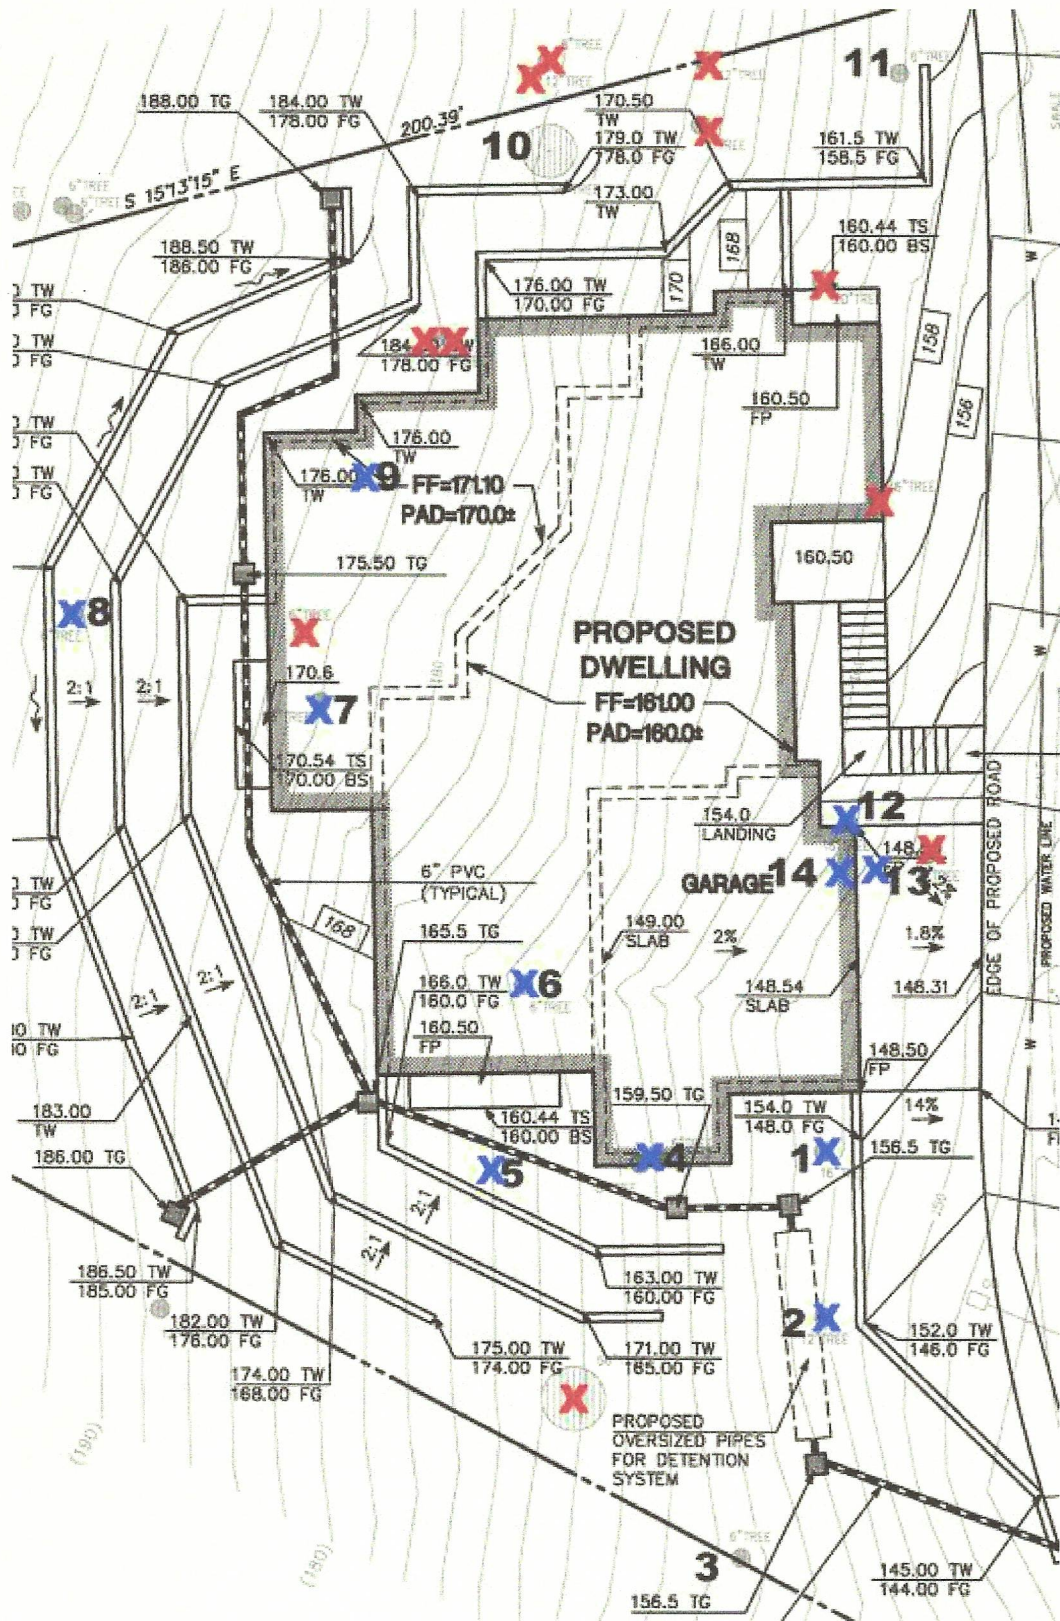
There are 14 trees included in this report. The trees not now included in the report are shown with a red "X" on the site plan. Trees to be removed due to construction are shown with a blue "X" on the site plan; they are trees numbered 1, 2, 4, 5, 6, 7, 8, 9, 12, 13, and 14. The retained trees numbered 3, 10, and 11 must be protected. Install chain link fencing supported by steel posts at the trees' driplines while still allowing for construction to proceed. See the attached *Mitigating Measures for Construction Impacts on Existing Trees*.

To conclude, only trees #3 and #10 are to remain; tree #11 can remain if the retaining wall is shortened.

I recommend having excavation inspected for potential root damage. At that time, recommendations for mitigating measures can be made for the retained trees. Tree #11 is shown to be removed, but retention should be attempted; tree #10 is a large bay. Bay trees are the main vector of sudden oak death disease, *Phytophthora ramorum*. Removal of all bays is not an option, as this is native oak/bay woodland.

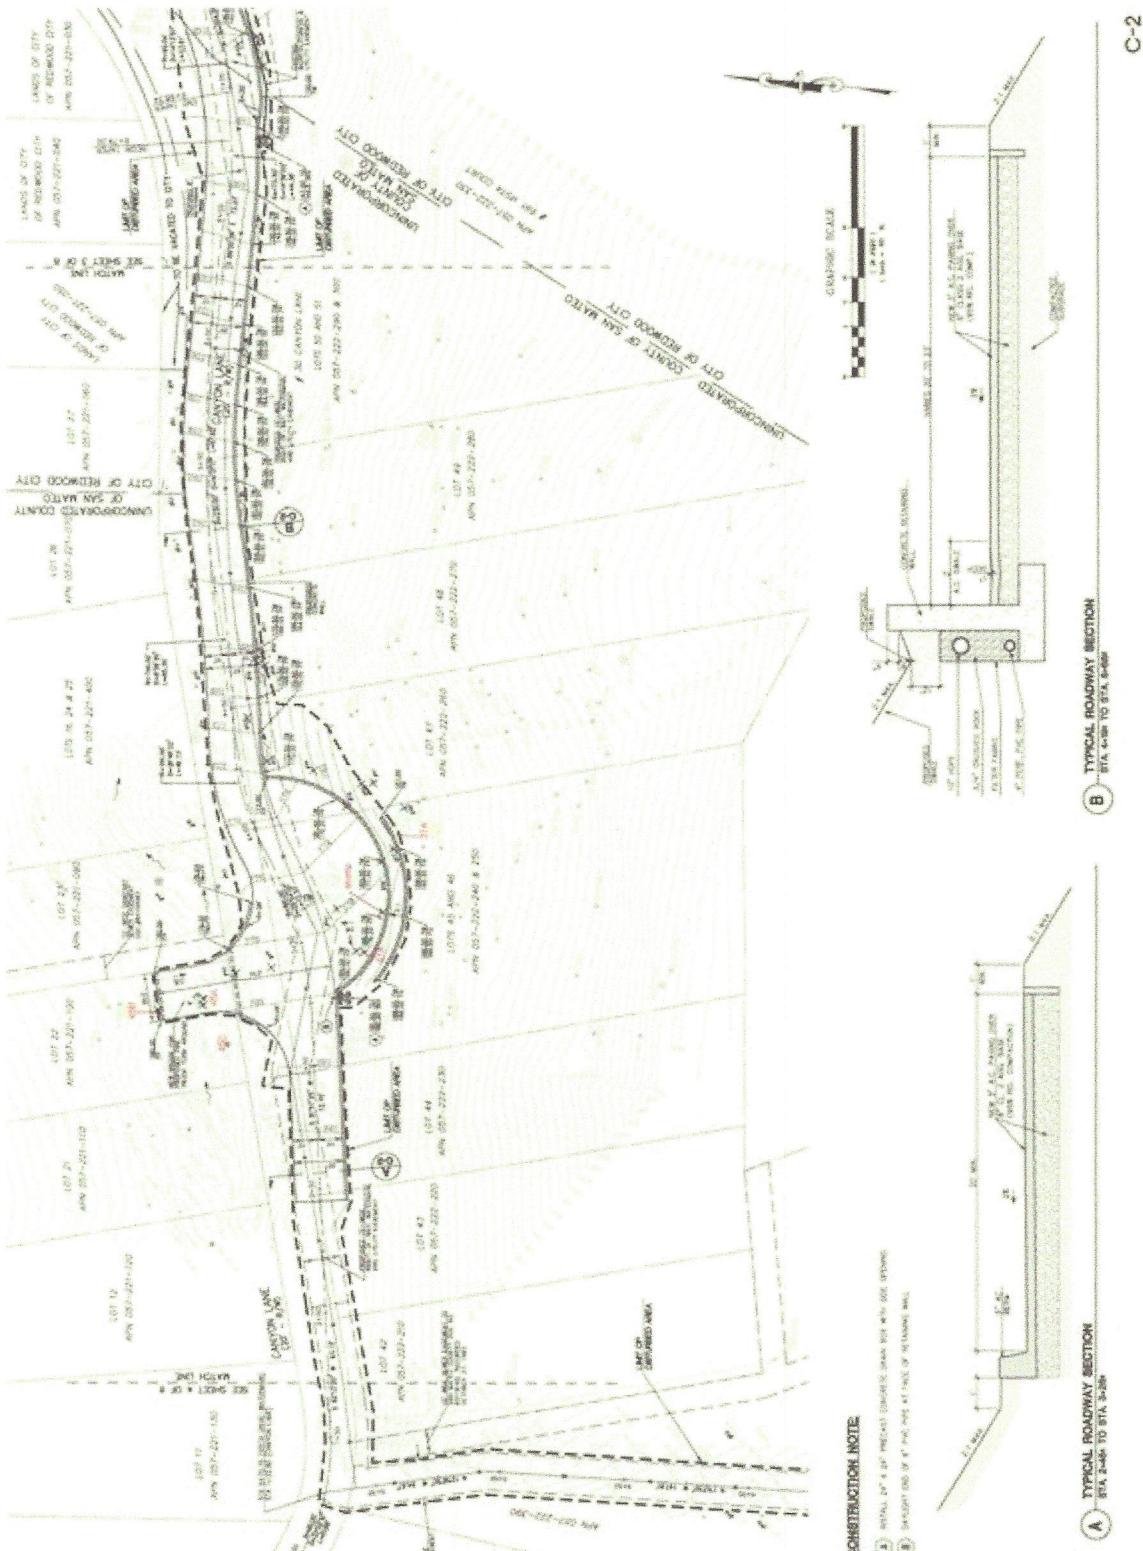
See C2 site plan attached to eMail with this letter.

To complete the proposed construction plan, there is a list of trees that will need to be removed. I have identified these trees as #1, #3, #4, #6, #10, #11, #12, #14, #18, #18A, #18B, #26, #27, #28, #32, #33, #34, #35, #37, #37A, #38, #39, #40, #41, #42, #45, #45A, #45B, #46, #47, #47A, and #54C. All of the previously-mentioned trees are either in poor condition or will be severely impacted by the proposed construction.

The remaining trees identified in this report, #2, #5, #7, #8, #9, #13, #15, #16, #17, #19, #20, #21, #22, #23, #24, #25, #29, #30, #31, #36, #43, and #44 that are located along the road will be partially impacted by the proposed construction. Either their canopies will need to be raised to provide adequate clearance for the construction traffic or portions of their root zones will be impacted by grade changes and the installation of asphalt for the new road.

Due to the type of project, I recommend removing all the trees that are designated for removal prior to performing any tree maintenance. After the removal stage of the project is completed, I recommend safety pruning to eliminate potentially hazardous large dead limbs, heavy lateral limbs, and exposing the root crowns of the trees to give them the best chance of survival into the future. All work performed shall be done by a qualified licensed tree care professional.
