April 20, 2022

CSA Project No: SMC6280A

SUBJECT: **Supplemental Engineering Geologic Peer Review**

RE: Mukaeda; New Residence on a Vacant Lot
PLN2020-00070
APN 037-221-020
"0" Cypress Avenue

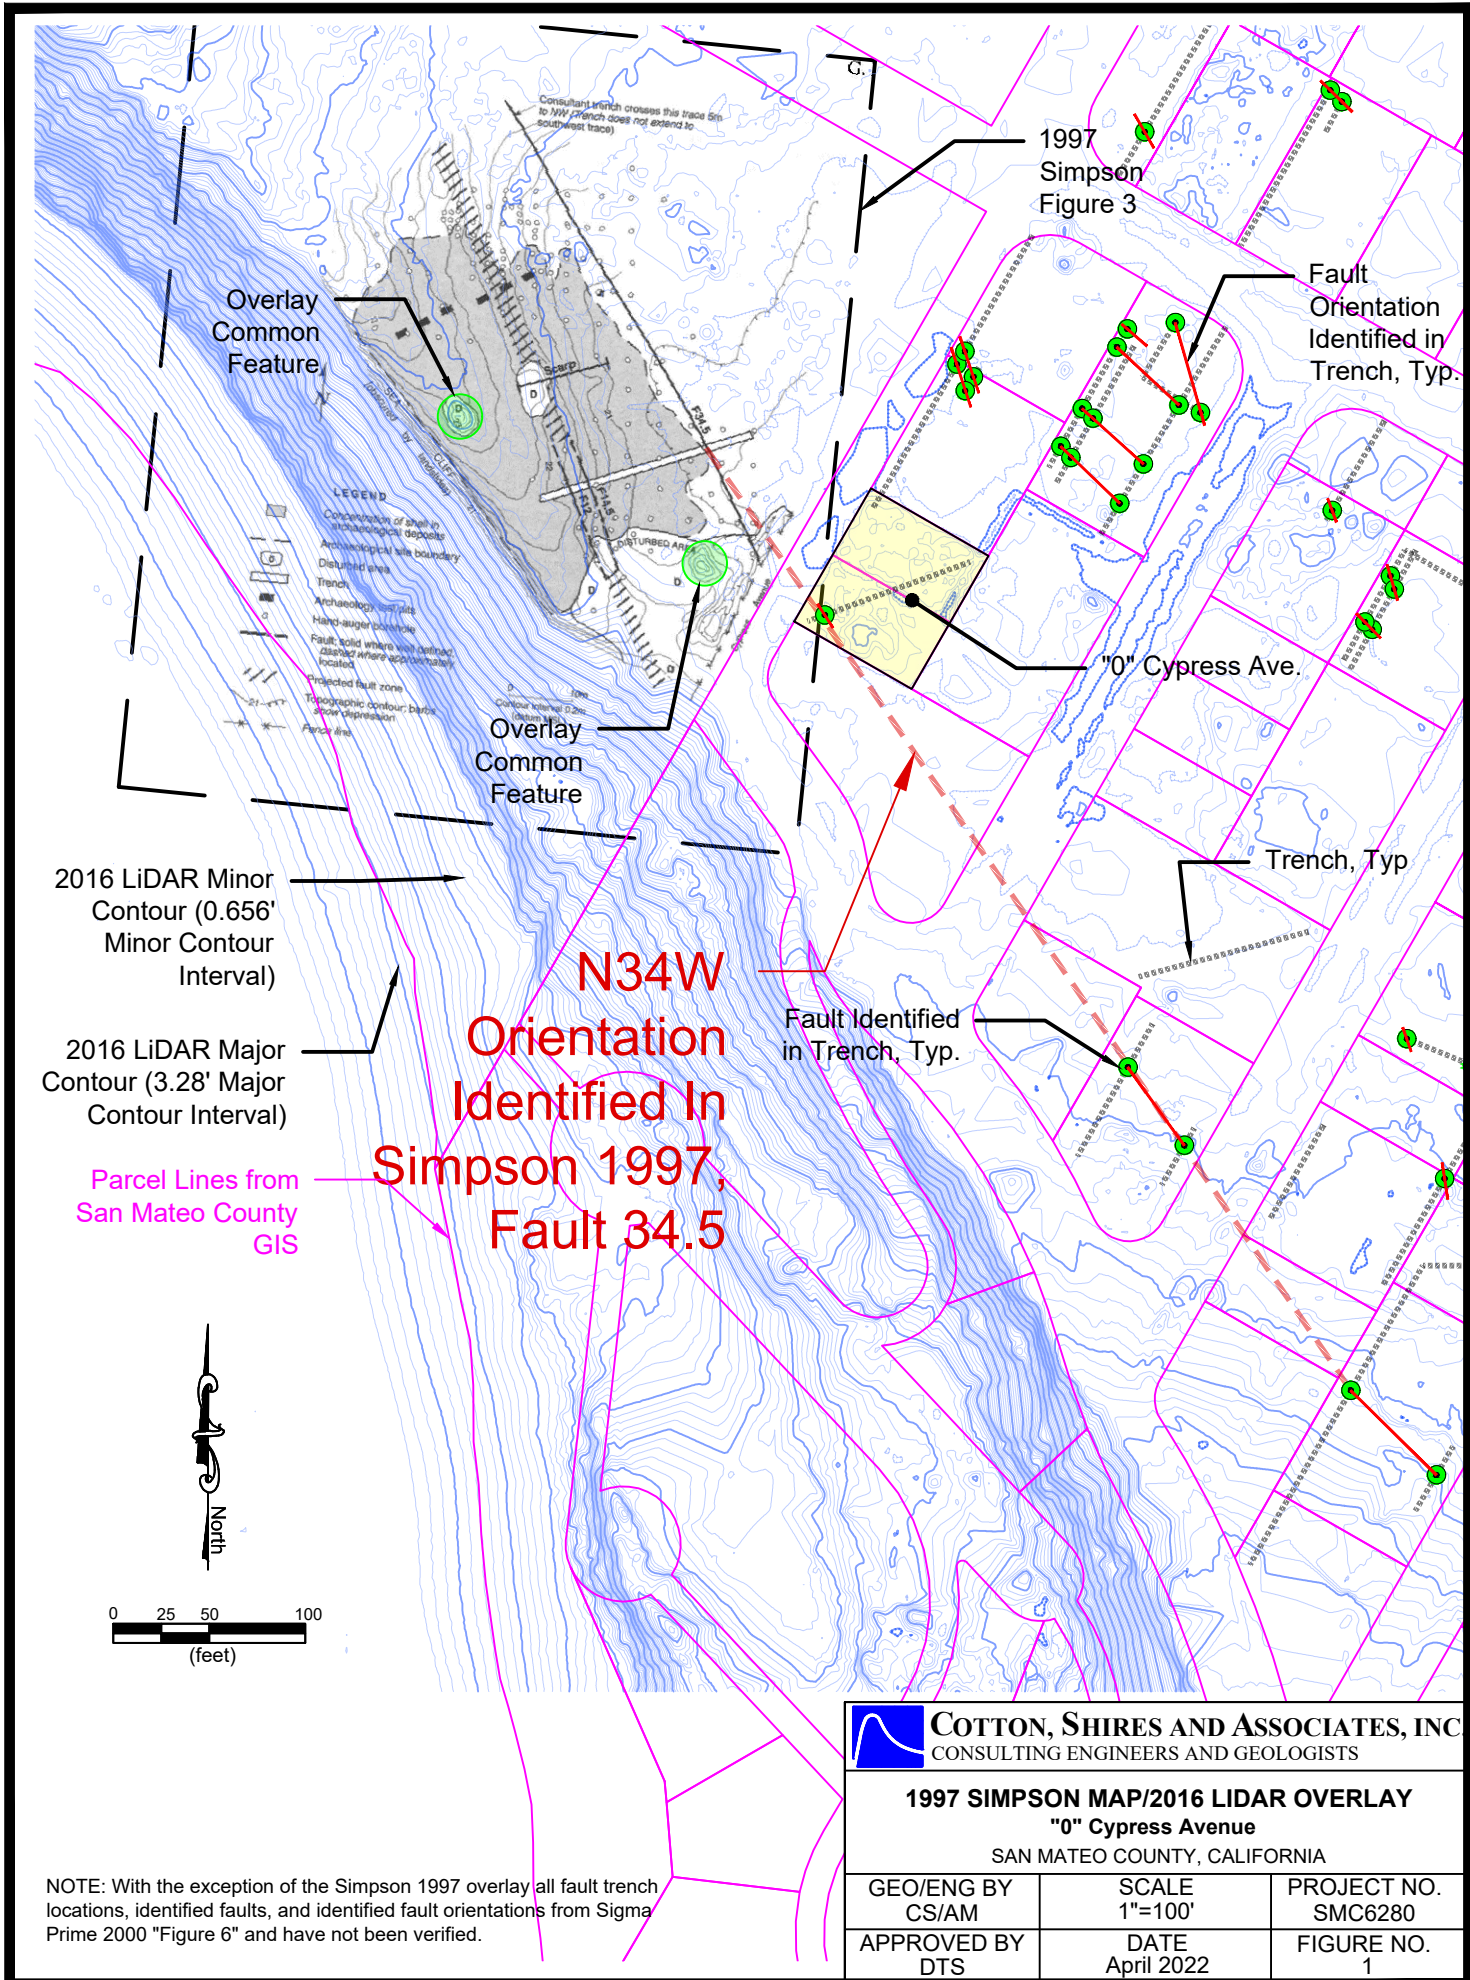
GEO/ENG BY CS/AM	SCALE 1"=100'	PROJECT NO. SMC6280
APPROVED BY DTS	DATE April 2022	FIGURE NO. 1

To further aide in the evaluation of surface fault rupture at the subject site we performed a limited analysis intended to better locate the Simpson 1997 trench for review by the Project Geologist (SPG). Utilizing the publicly available LiDAR data set "2016 USGS West Coast El-Nino LiDAR DEM" as a base map, we identified distinct topographic features (mounds) that appear on both the 2016 LiDAR and on Figure 3 of the Simpson report (see Figure 1). We plotted contour intervals (0.656 feet minor and 3.28 feet major) to match those included on Figure 3 of the Simpson report, which provides measurements and scales in meters and uses a 1-meter major contour interval and a 0.2-meter minor contour interval. To confirm whether our georeferencing of the 1997 trench location was reasonable we plotted a topographic profile utilizing the 2016 LiDAR data in relation to the trench log profile (see Figure 2). We note that based on our georeferencing of Figure 3 of the Simpson 1997 report we believe that north is slightly misoriented as published. We also include a straight line extending south from the trench and fault trace location identified in the Simpson report, and oriented N34W as measured in the Simpson report.

N34W Orientation Identified In Simpson 1997, Fault 34.5

Consequently, we find that conclusions and analysis provided for our peer review are incomplete and we recommend the Project Geologist consider the likelihood that the fault trace logged on the western side of the subject property represents a through-going active fault zone associated with the Seal Cove Fault.

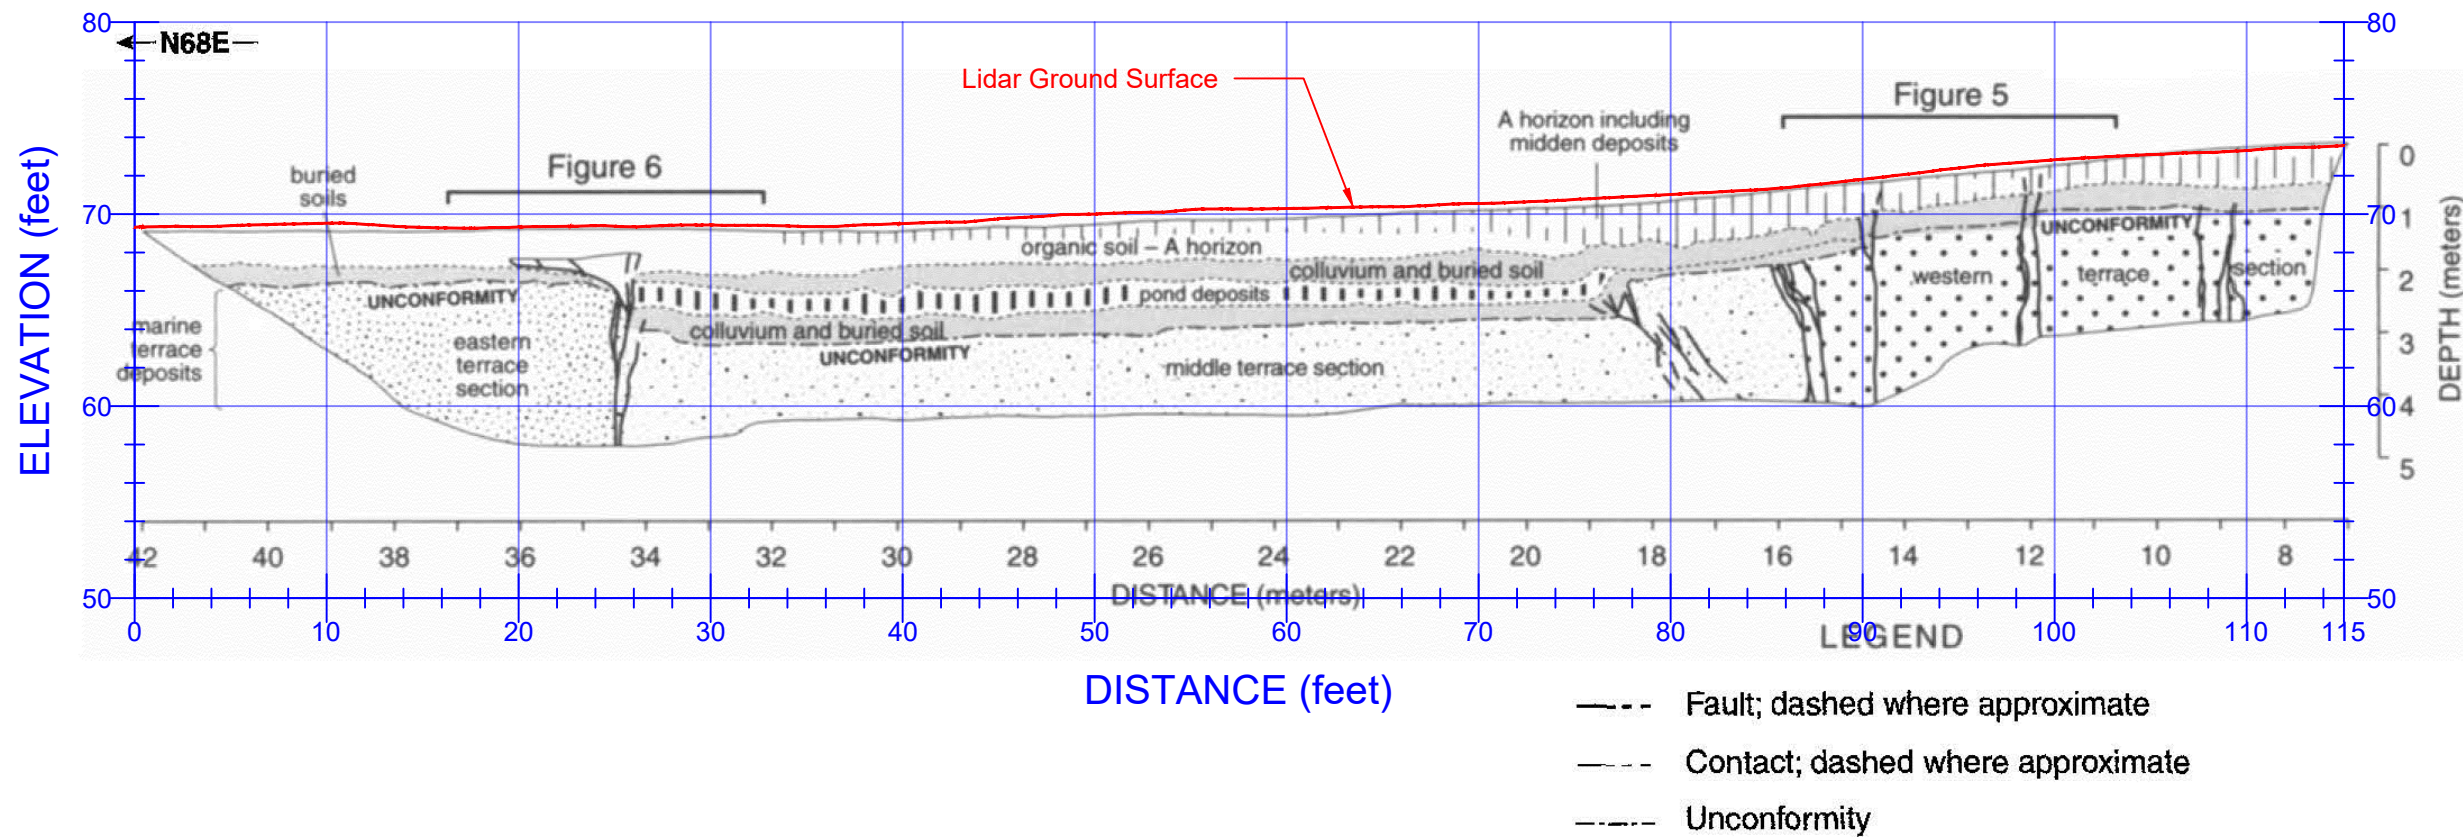
COTTON, SHIRES AND ASSOCIATES, INC. CONSULTING ENGINEERS AND GEOLOGISTS		
2016 LIDAR PROFILE/1997 SIMPSON OVERLAY "0" Cypress Avenue SAN MATEO COUNTY, CALIFORNIA		
GEO/ENG BY CS/AM	SCALE 1"=10'	PROJECT NO. SMC6280
APPROVED BY DTS	DATE April 2022	FIGURE NO. 2

We also find that active faulting described in the trench north of the site has not been adequately considered in the supplemental analysis and discussion provided by the Project Geologist. Specifically, the approximately 0.5-foot to 1.5-foot-wide trace oriented N34W at station F34.5 of the Simpson (1997) trench which we understand was also encountered in an additional trench north of the Simpson study per Figure 3 of the 1997 report.

Figure 4. Schematic log of the Seal Cove trench, view to the southeast, showing principal stratigraphic groups and faults. Horizontal scale is tied to an arbitrary survey station 7 m southwest of the end of the trench.
