**ENGINEERING GEOLOGIC &
GEOTECHNICAL INVESTIGATION
4-LOT RESIDENTIAL DEVELOPMENT
ZMAY PROPERTY
1551 CRYSTAL SPRINGS ROAD
SAN MATEO COUNTY, CALIFORNIA**

February 10, 2014
Project No. 1847-1R1

**RE: ENGINEERING GEOLOGIC &
GEOTECHNICAL INVESTIGATION,
4-LOT RESIDENTIAL DEVELOPMENT,
ZMAY PROPERTY,
1551 CRYSTAL SPRINGS ROAD,
SAN MATEO COUNTY, CALIFORNIA**

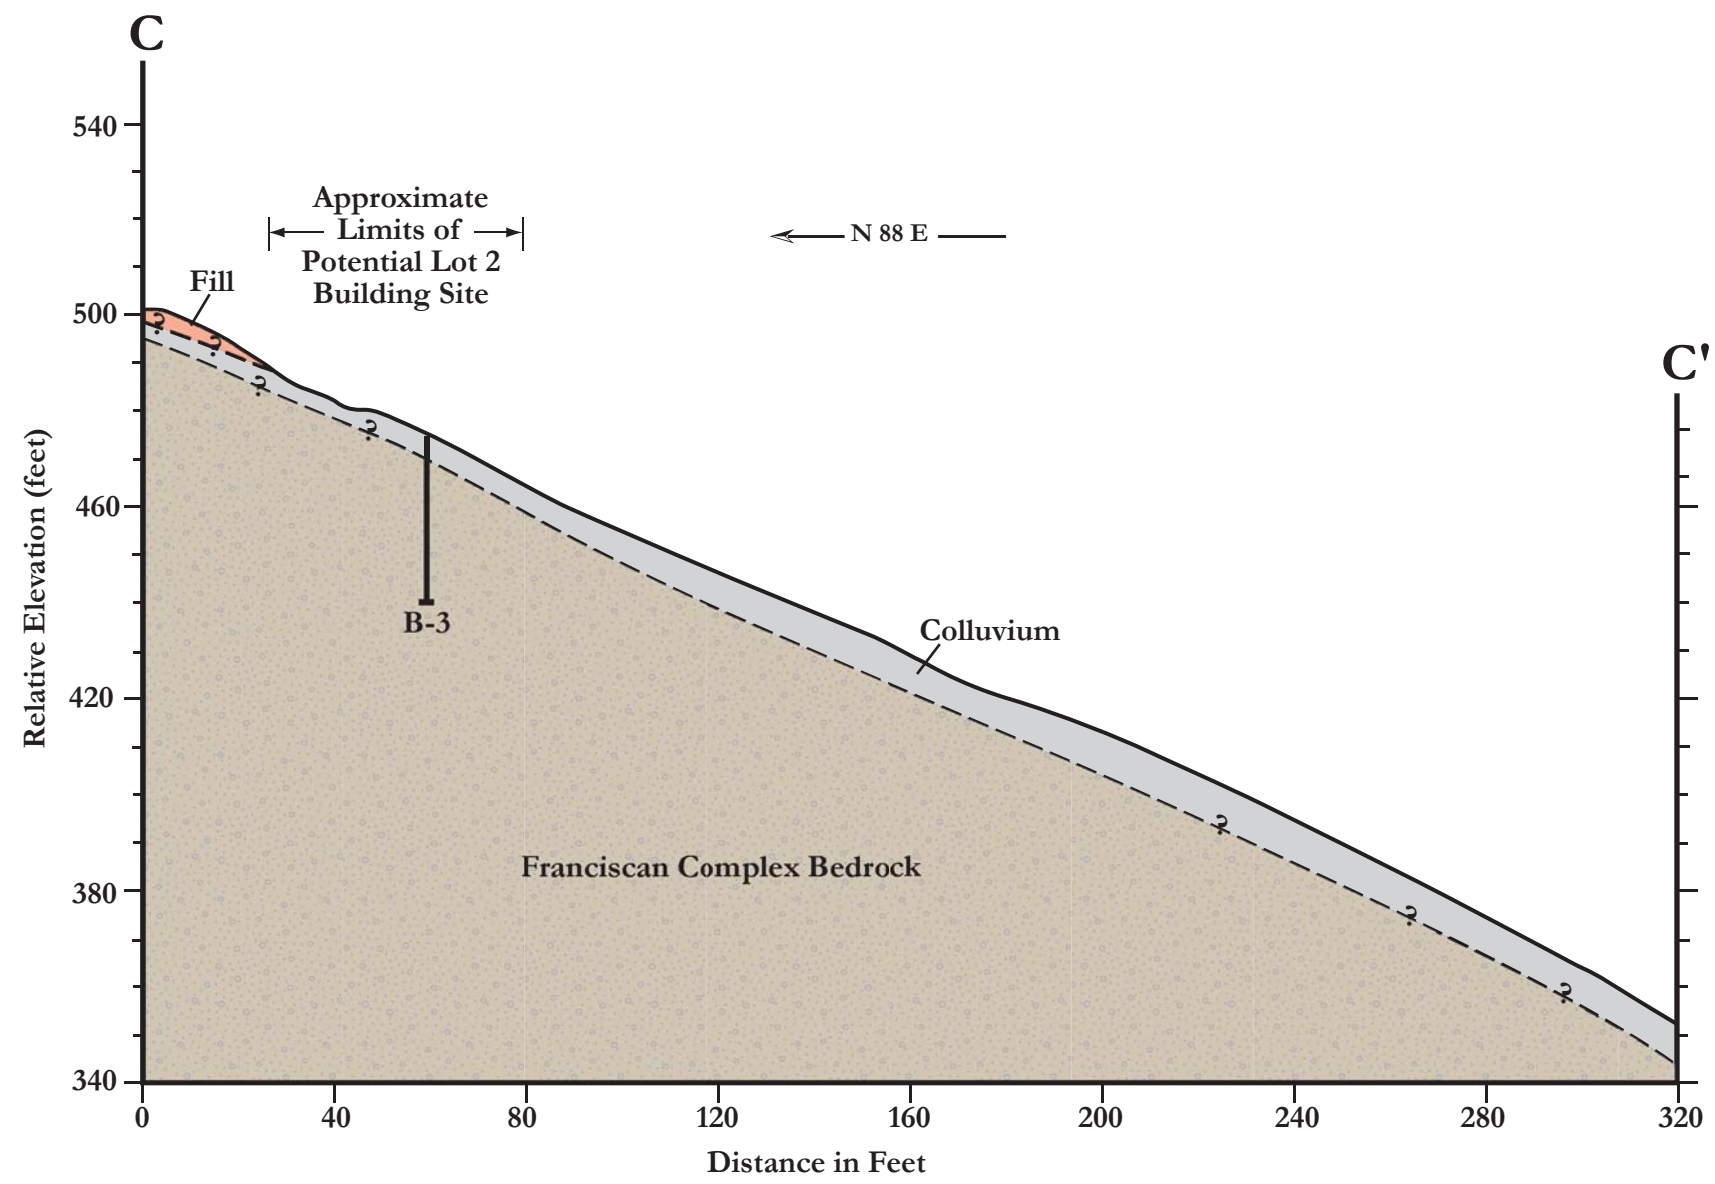
GEOLOGIC CROSS-SECTION B-B'	
	ZMAY RESIDENTIAL SUBDIVISION 1551 CRYSTAL SPRINGS ROAD SAN MATEO COUNTY, CALIFORNIA	
PROJECT NO. 1847-1R1	FEBRUARY 2014	FIGURE A-7

Based on the reconfiguration of parcel boundaries, the majority of the mapped active landslide is located within Parcel 2. Please refer to Figure 1 for the reconfiguration of the proposed parcel lines and refer to Cross Section B-B' (Figure A-7) of MEI's 2014 report for reference. We understand that the project civil engineer will be providing a cross section depicting the proposed landslide repair, including keying and benching details of the fill, fill subdrainage, and grading volumes.

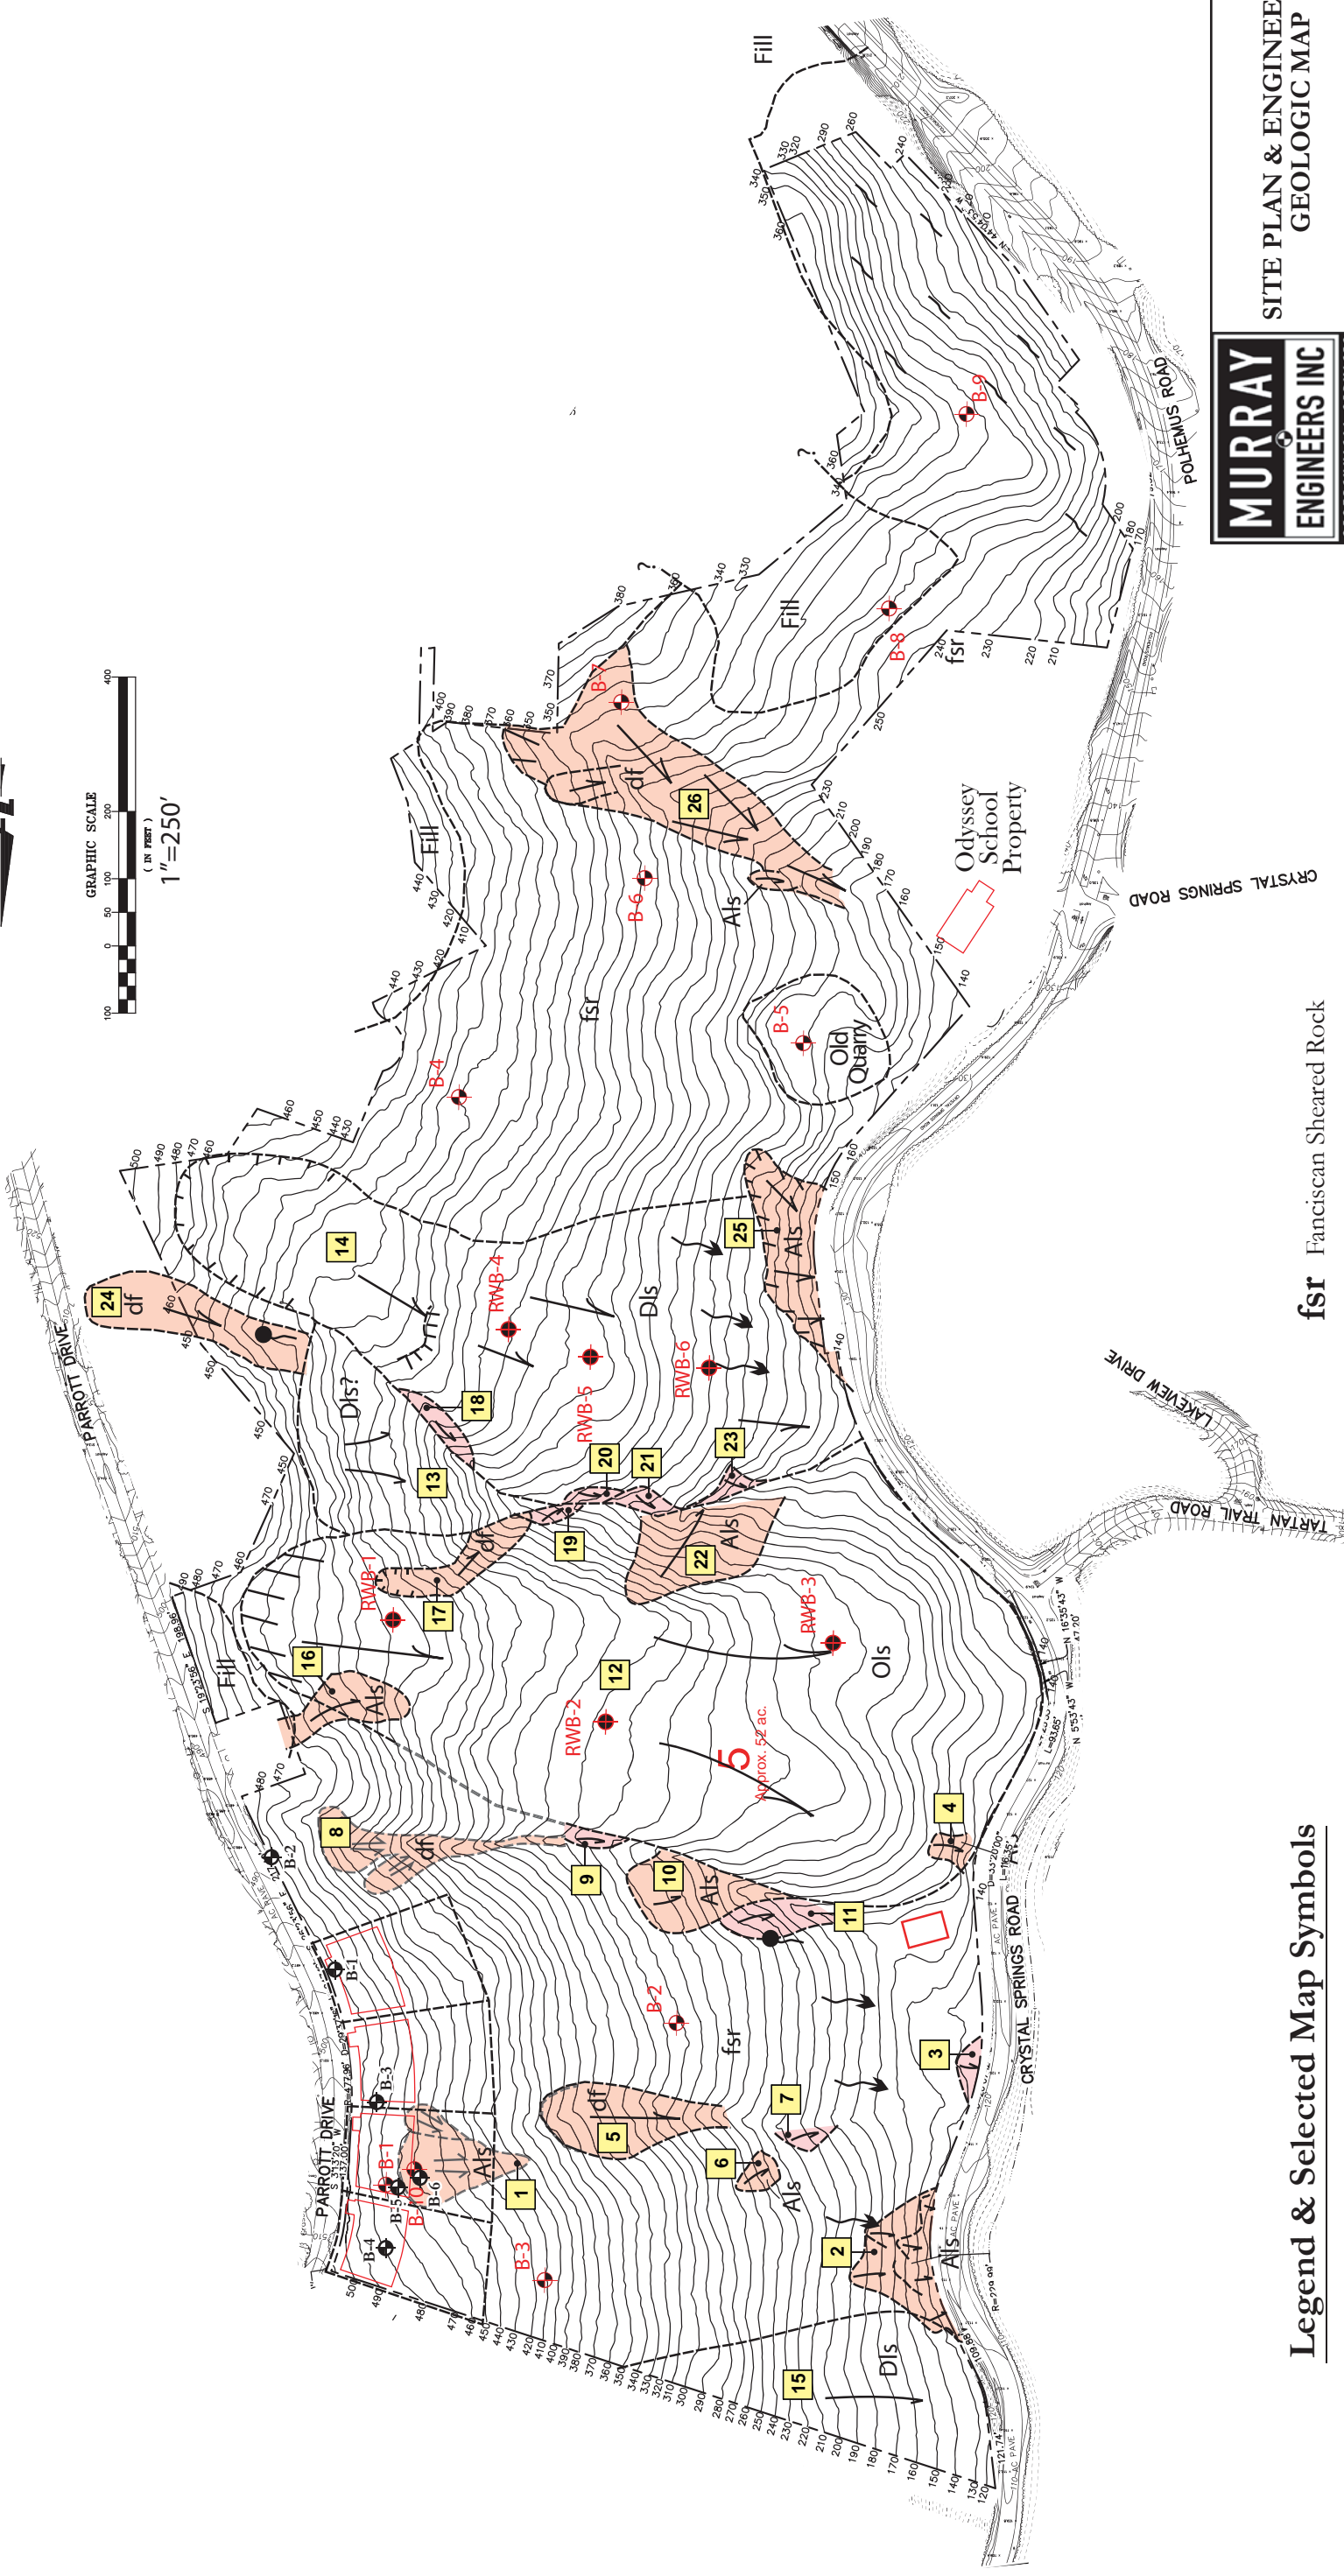
FIGURE 1

Below is a discussion of the landslide features mapped on Figure 1, moving north to south across the property. For ease of reference, these features discussed below are also numbered on Figure 1.

A graded road/path enters the property near the eastern margin of the mapped ancient landslide (Ols) and continues in a southwesterly direction toward the mapped quarry. This grading is associated with the existing sewer line that services residences along Parrott Drive. Along the uphill side of this access road, Franciscan materials are exposed that range from relatively competent rock outcrops to highly sheared, severely to completely weathered materials. During site mapping, we observed an arcuate break in slope below the road, located uphill from boring RWB-4 (see Figure 1 within Landslide 14). While this feature may be a scarp related to past movement, the surrounding topography and relatively close position to the graded access road appear to suggest that this feature is likely a remnant associated with past grading. We did not see additional features similar in nature to this on the property, but it is possible they were obscured by the dense vegetation.
